The purpose of the ACCC® Conductor Maintenance and Repair Manual is to provide experienced personnel with guidelines, recommendations, and the requirements necessary to successfully Maintain and Repair ACCC Conductor and associated accessories.

These guidelines apply to all sizes and types of ACCC Conductor and associated hardware, including Ultra-Low Sag (ULS), Ultra-High Strength (AZR™) (Ice Load), and ACCC InfoCore®.

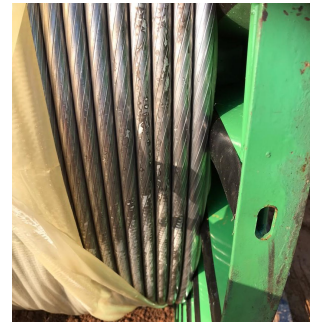
Figure 1 - Water Stain

When conductor reels are stored outdoors, moisture can be trapped in wrapping material next to the conductor, this is often found at the bottom of the reel where water has pooled. The moisture can combine with chemicals from the surrounding atmosphere, and a black stain can appear on the conductor. This has been found to be more prevalent in non-specular conductor as the drawing oils have been removed.

Water stains are a cosmetic issue; they have no adverse effect on the performance or service life of the conductor. In many environments, the conductor will darken in the first few months the line is energized, and water stains will no longer be noticeable.

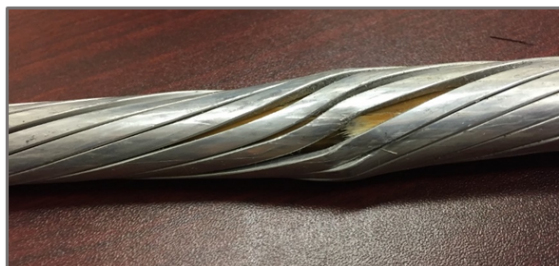
Figure 2 - Strand Loosening Due to Core Damage

It is likely that any strand loosening or birdcage observed would have been caused and not rectified correctly during installation, as birdcage does not normally occur during service. However, anomalies in the conductor strands can also be a telltale sign of a broken core and therefore further examination must be undertaken.

If the loosening is not too severe and the cross-sectional area of aluminum remains intact, then the electrical performance will not be affected. Where strand loosening is observed there is a possibility that debris could build up between the open strands. This has the potential to cause corona or noise.

Where strand loosening is observed always carry out further checks to ensure the core has not been damaged.

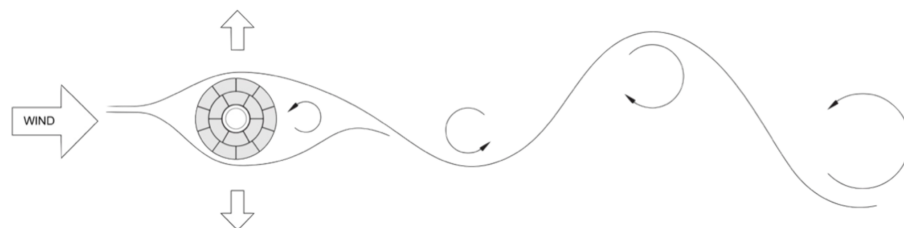
Figure 3 - Aeolian Vibration

Aeolian Vibration is a high frequency motion (10 to 250 Hz) which can occur under smooth wind conditions (8 to 24 km/h or 5 to 15 mph) across the conductor surface, resulting in cyclic bending at the supporting hardware (i.e., dead-ends, splices, suspension clamps,) and causing damaging stress fatigue and strand breakage.

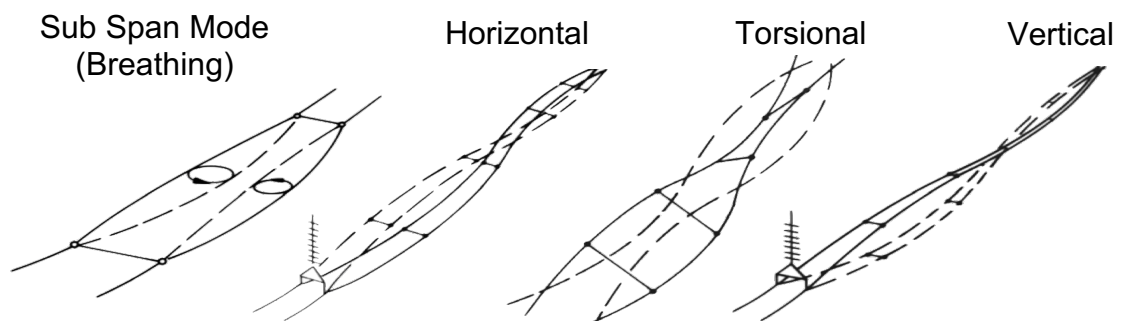
Wake-induced oscillations, (winds of 10 to 40 mph) appear only in bundled conductors. They are due to the shielded conductor lying in the wake of the windward conductor. The oscillations may be vertical, horizontal, or torsional in motion. Cyclic stress fatigue can break strands at spacers, dead-ends, etc.

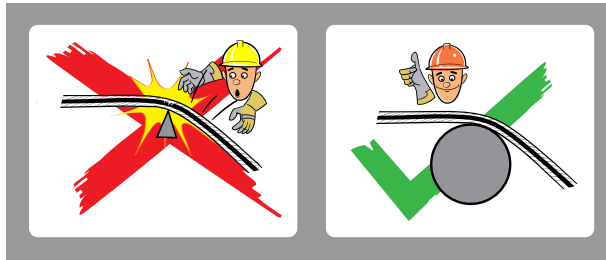
Don't allow tensioned conductor to contact surfaces that present sharp angles or small diameters.

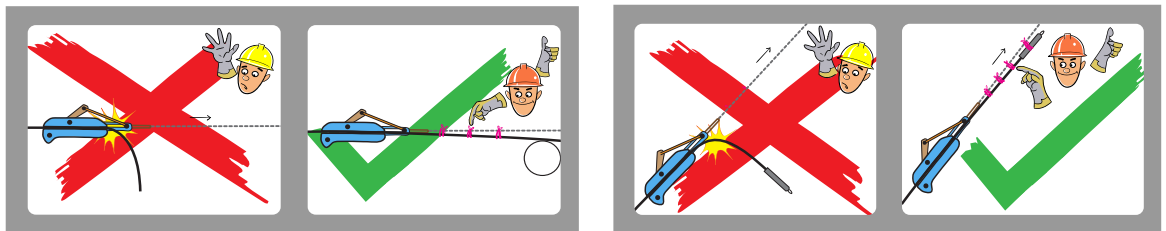
Don't allow the conductor tail or the dead-end to fall or droop unsupported while handling the conductor. If the tail is not controlled, it will damage the core at the back of the grip.

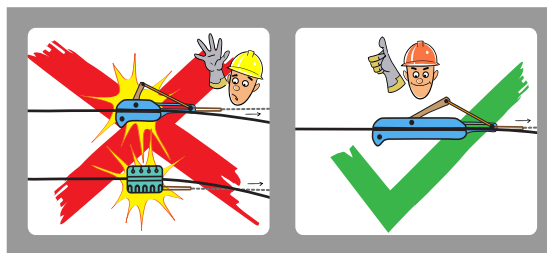
Don't allow the conductor tail or the dead-end to fall or droop unsupported while handling the conductor. If the tail is not controlled, it will damage the core at the back of the grip. Don't use pocketbook grips or short-jaw parallel jaw grips.

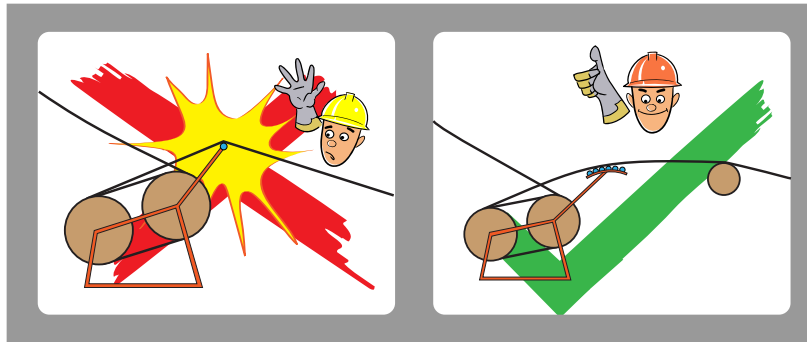
Don't let ACCC Conductor run hard against any roller of the fairlead. Always use a tensioner feed sheave (meeting minimum sheave diameter requirements) between the payout reel and tensioner to guide the conductor into the middle of the tensioner fairlead opening.

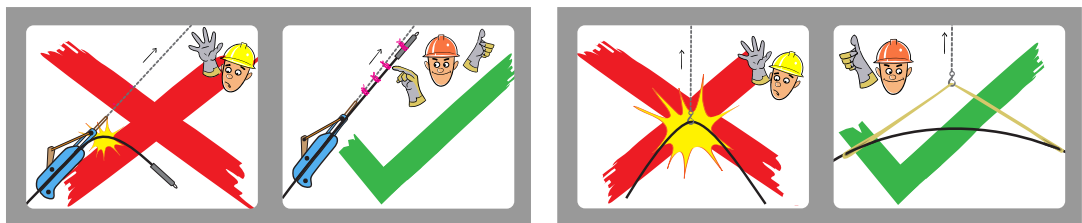
Don't hoist or handle the conductor in any manner which causes a sharp bend in the conductor.

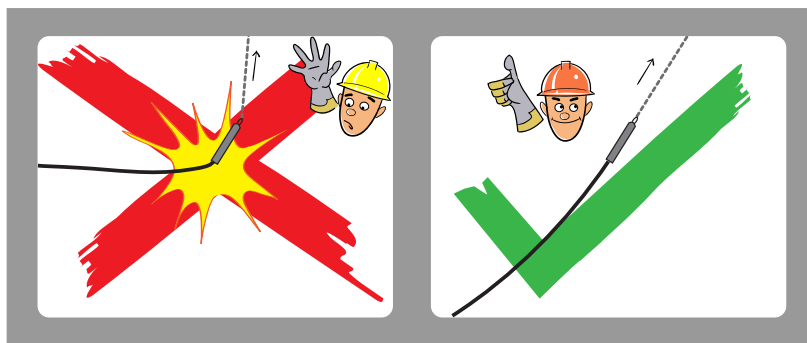
Don't allow a sharp bend where the conductor exits the termination hardware. Hoisting conductor or dead-end without paying attention to this area can damage the core at that point.
